THE GREAT ALASKA EARTHQUAKE

Volume II

Illustrations and Maps

TECHNICAL REPORT NO. AFWL-TR-65-92, Vol II

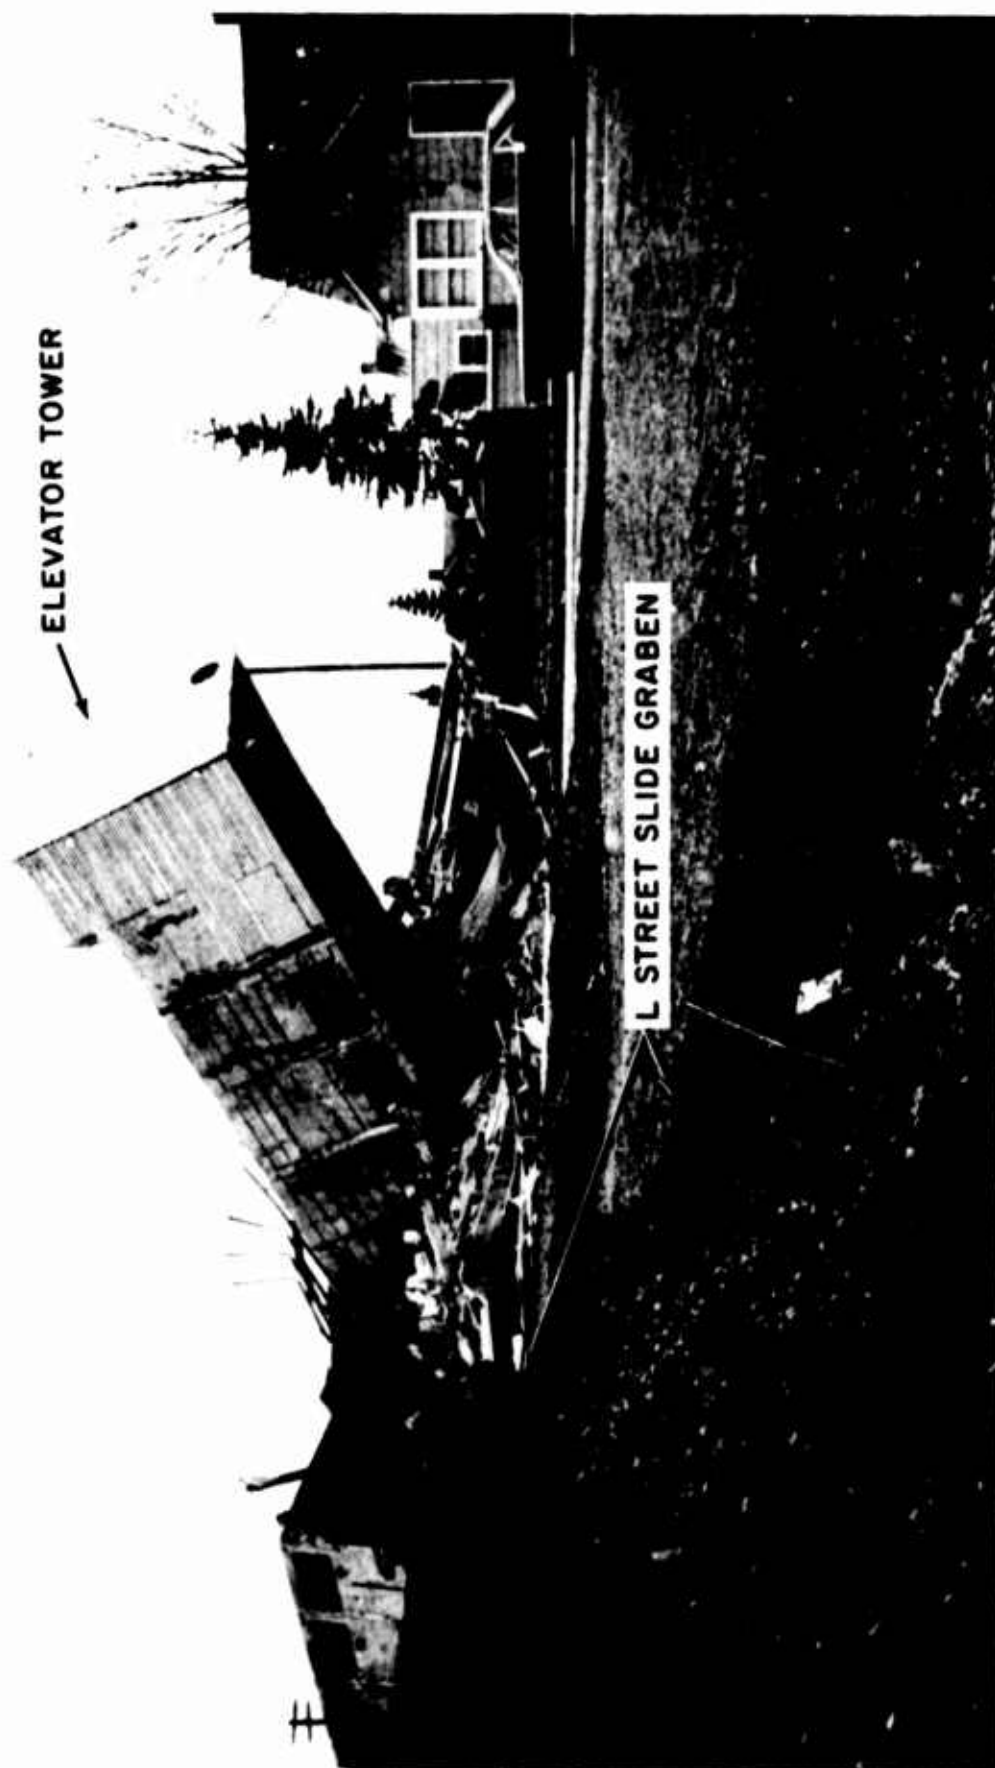
Figure 189. Four Seasons Apartments
(East side of the collapsed structure showing a portion of the L Street slide graben)

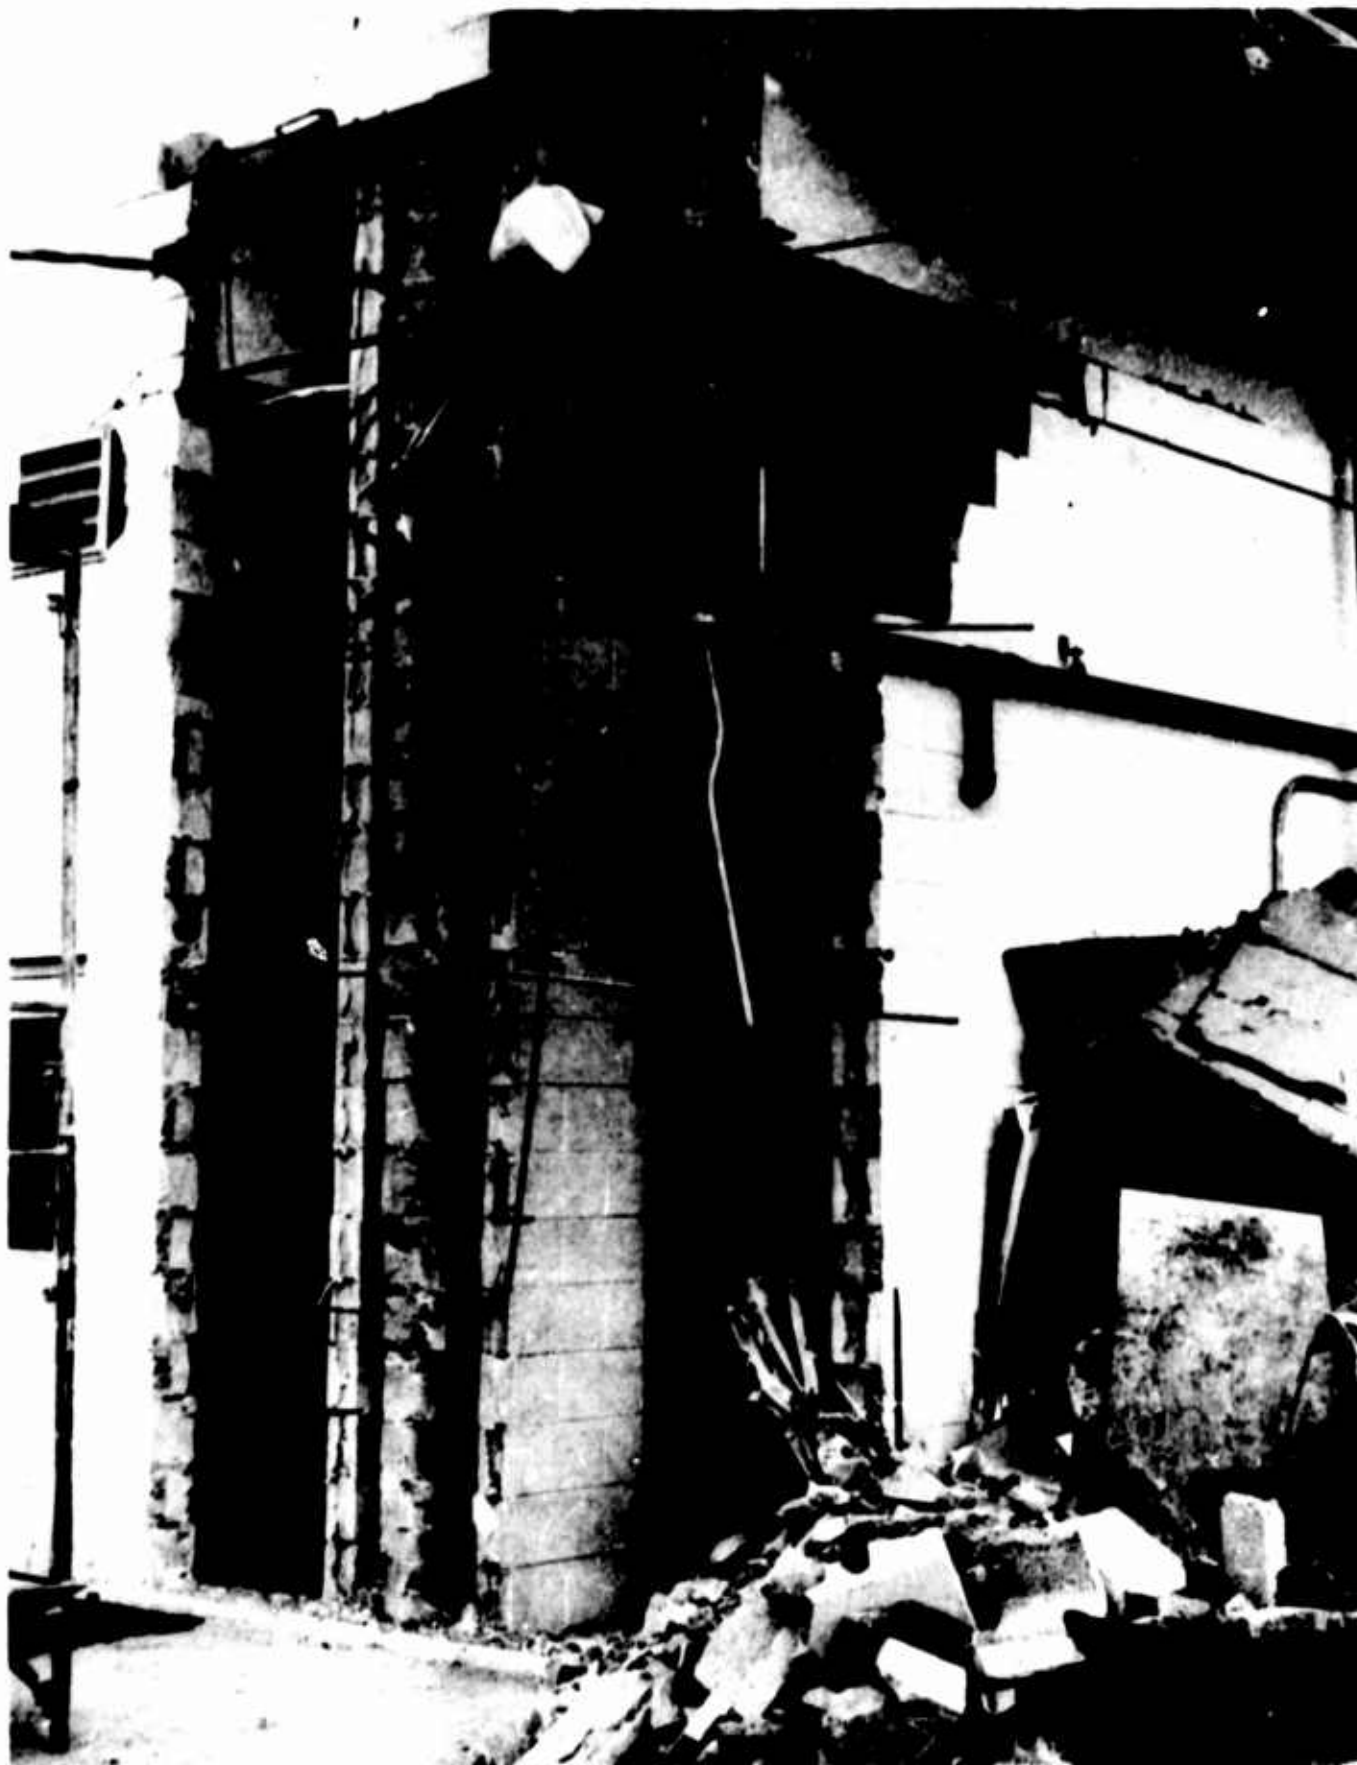
Figure 200. Fifth Avenue Chrysler Center (Damage to the structure progressed back to an interior masonry wall which provided sufficient rigidity to hold a roof beam in place and prevent further damage to those beyond)

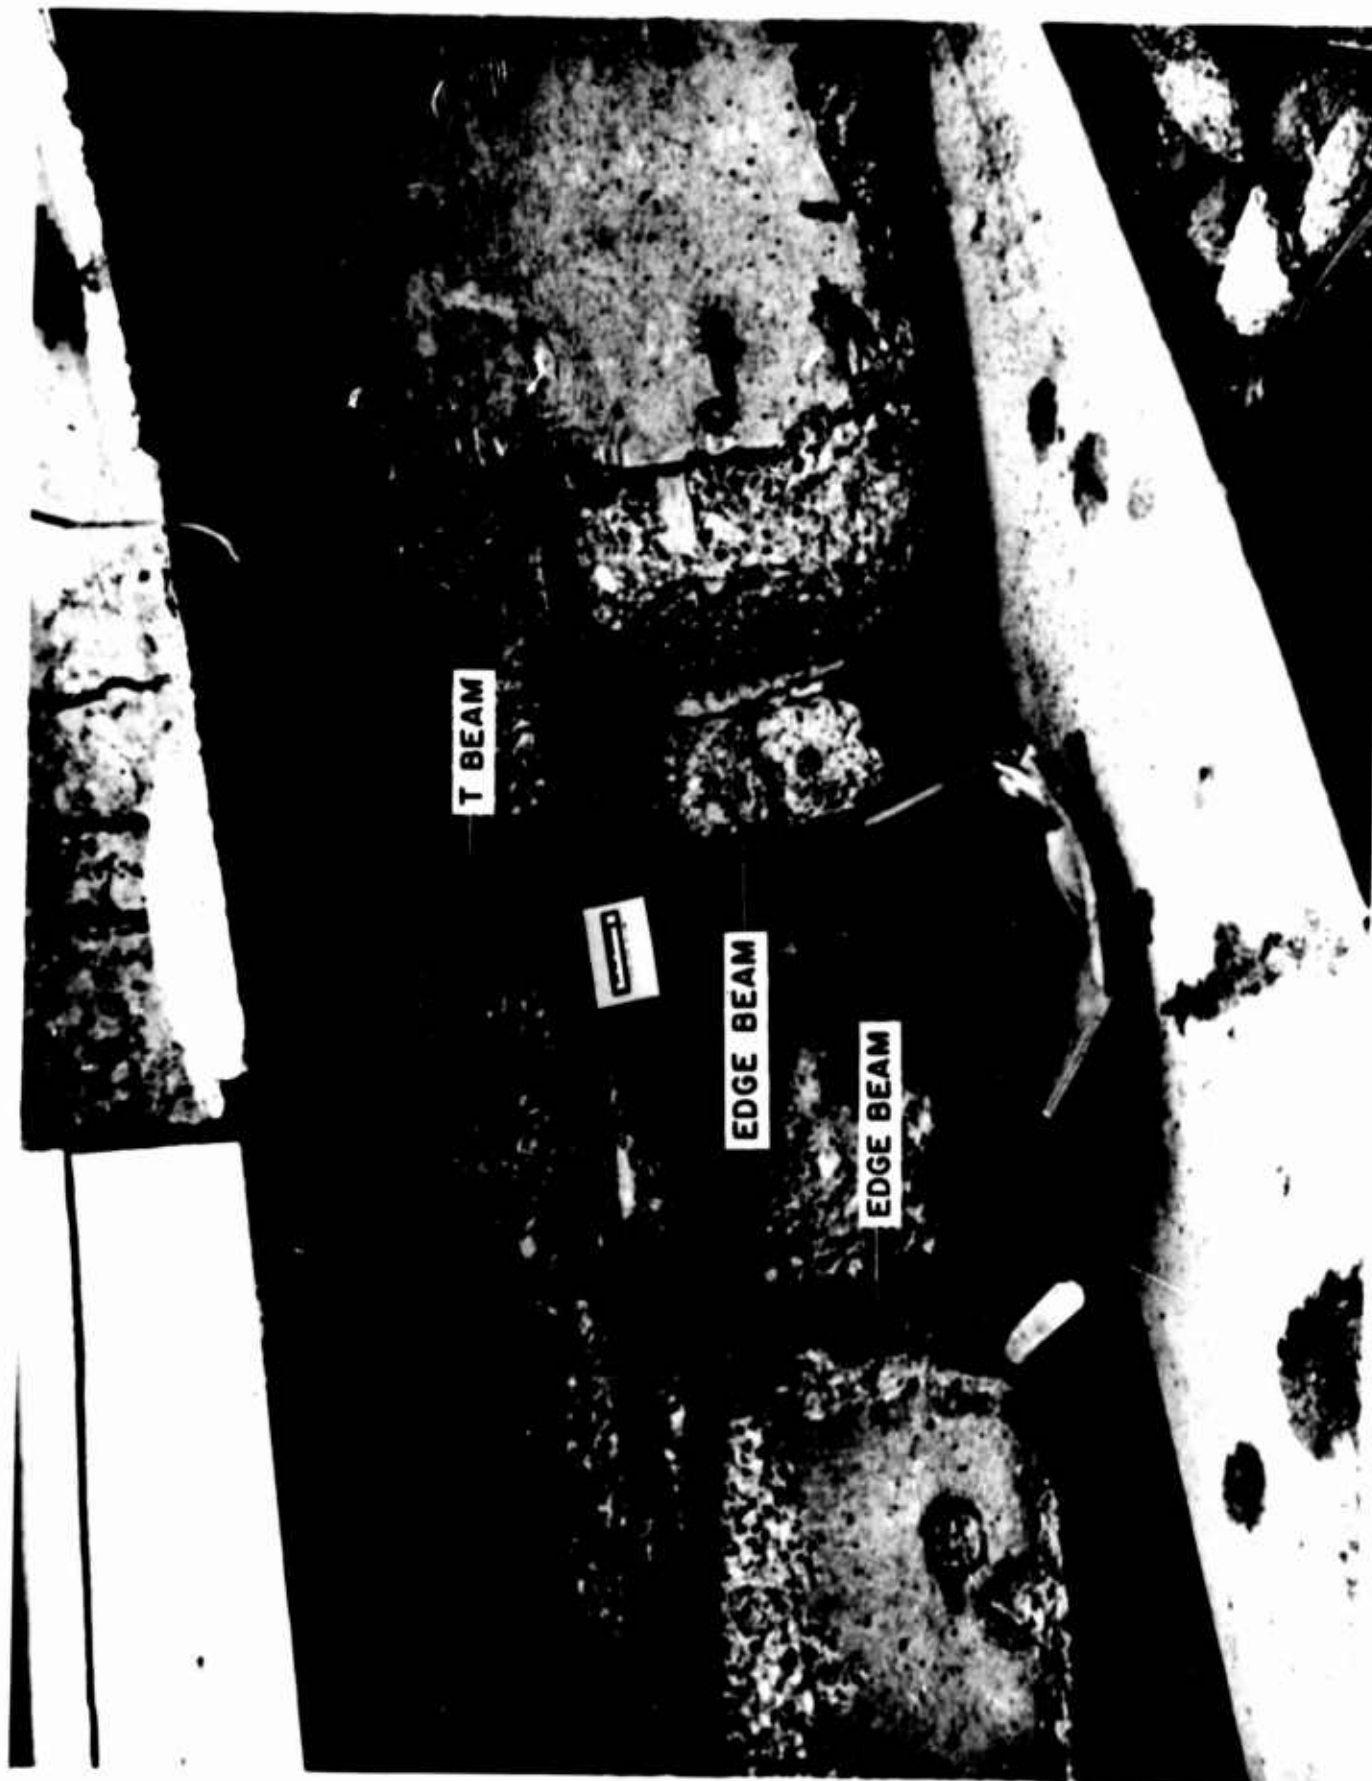
Figure 204. Gay Airways Hangar (End connection for one of the prestressed T-roof beams)

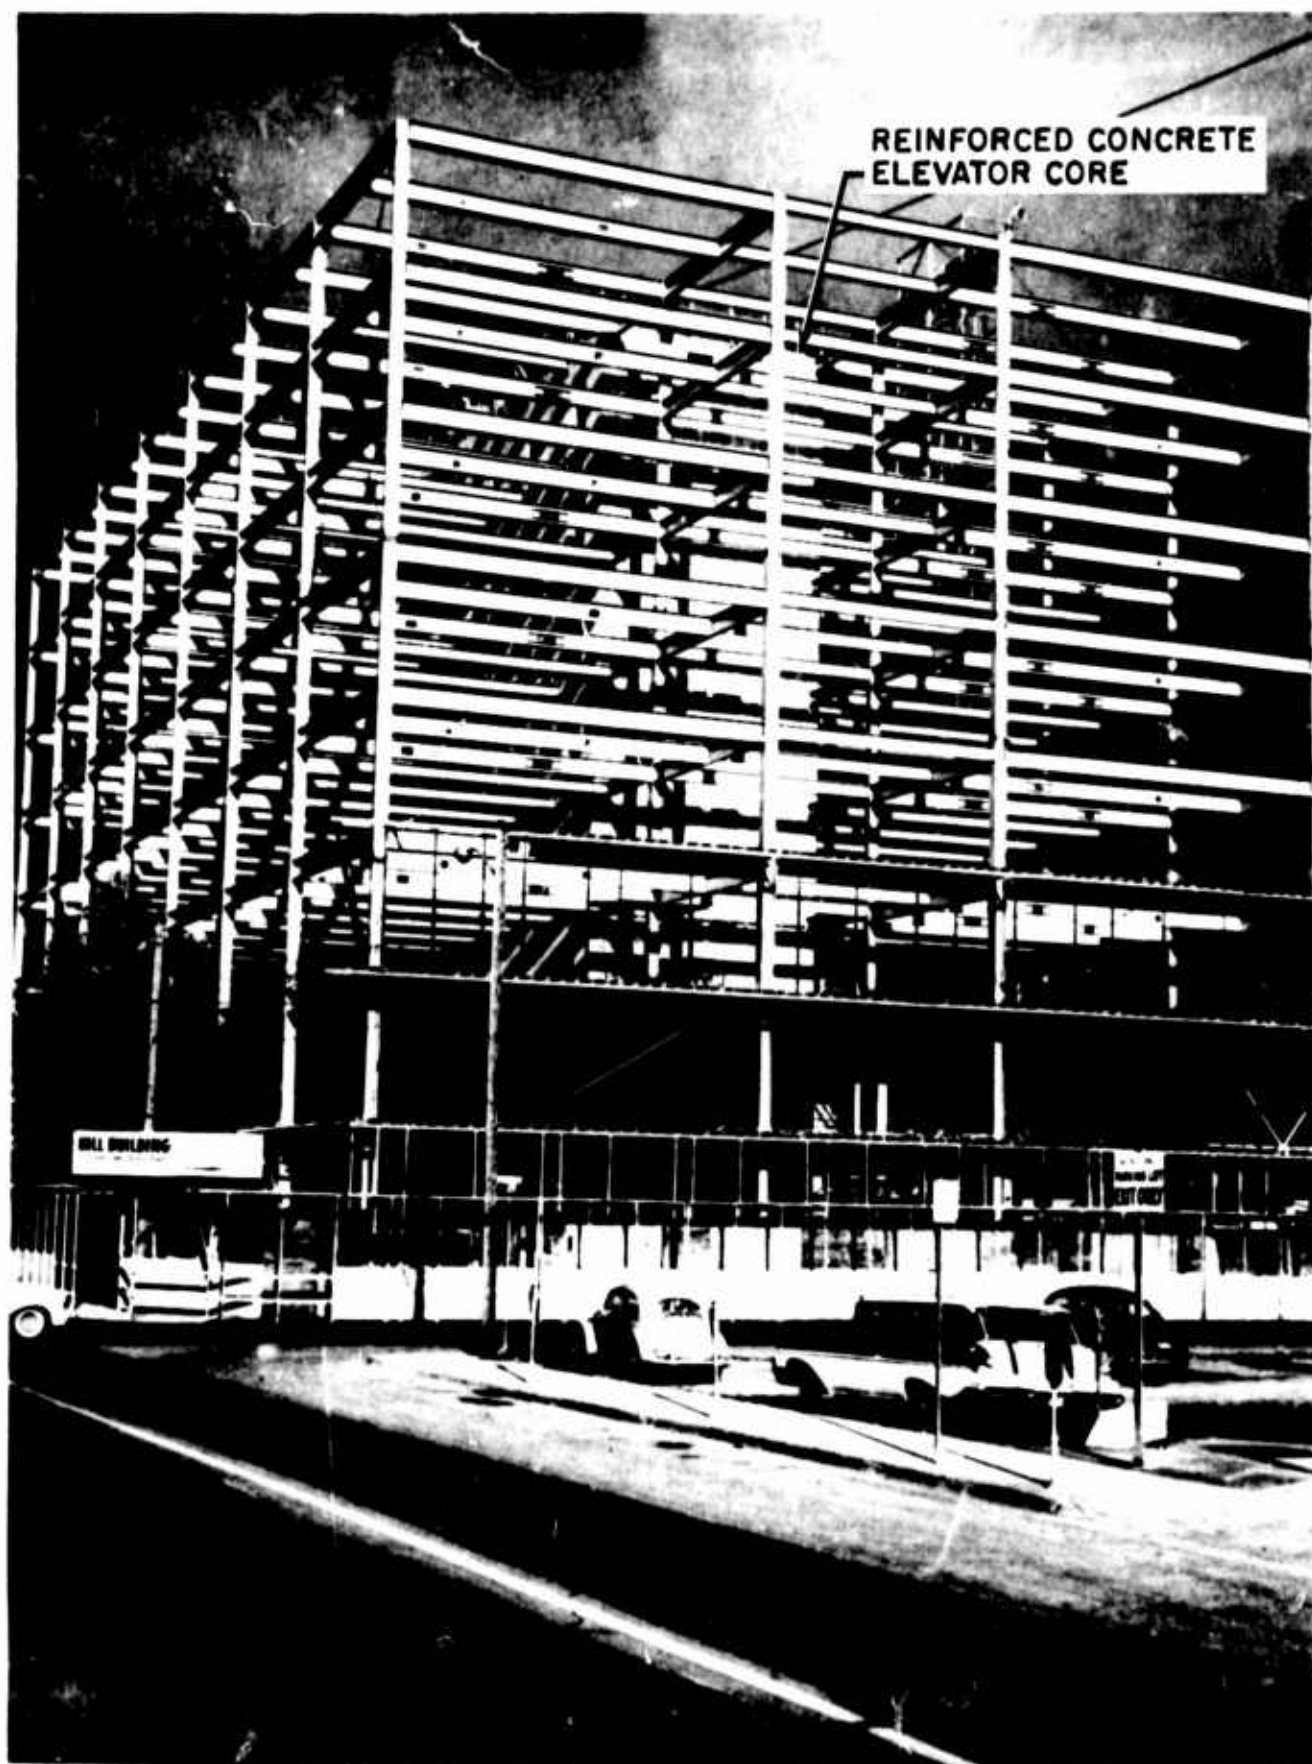
Figure 216. Hill Building
(West side of building under construction showing steel frame and elevator cores)

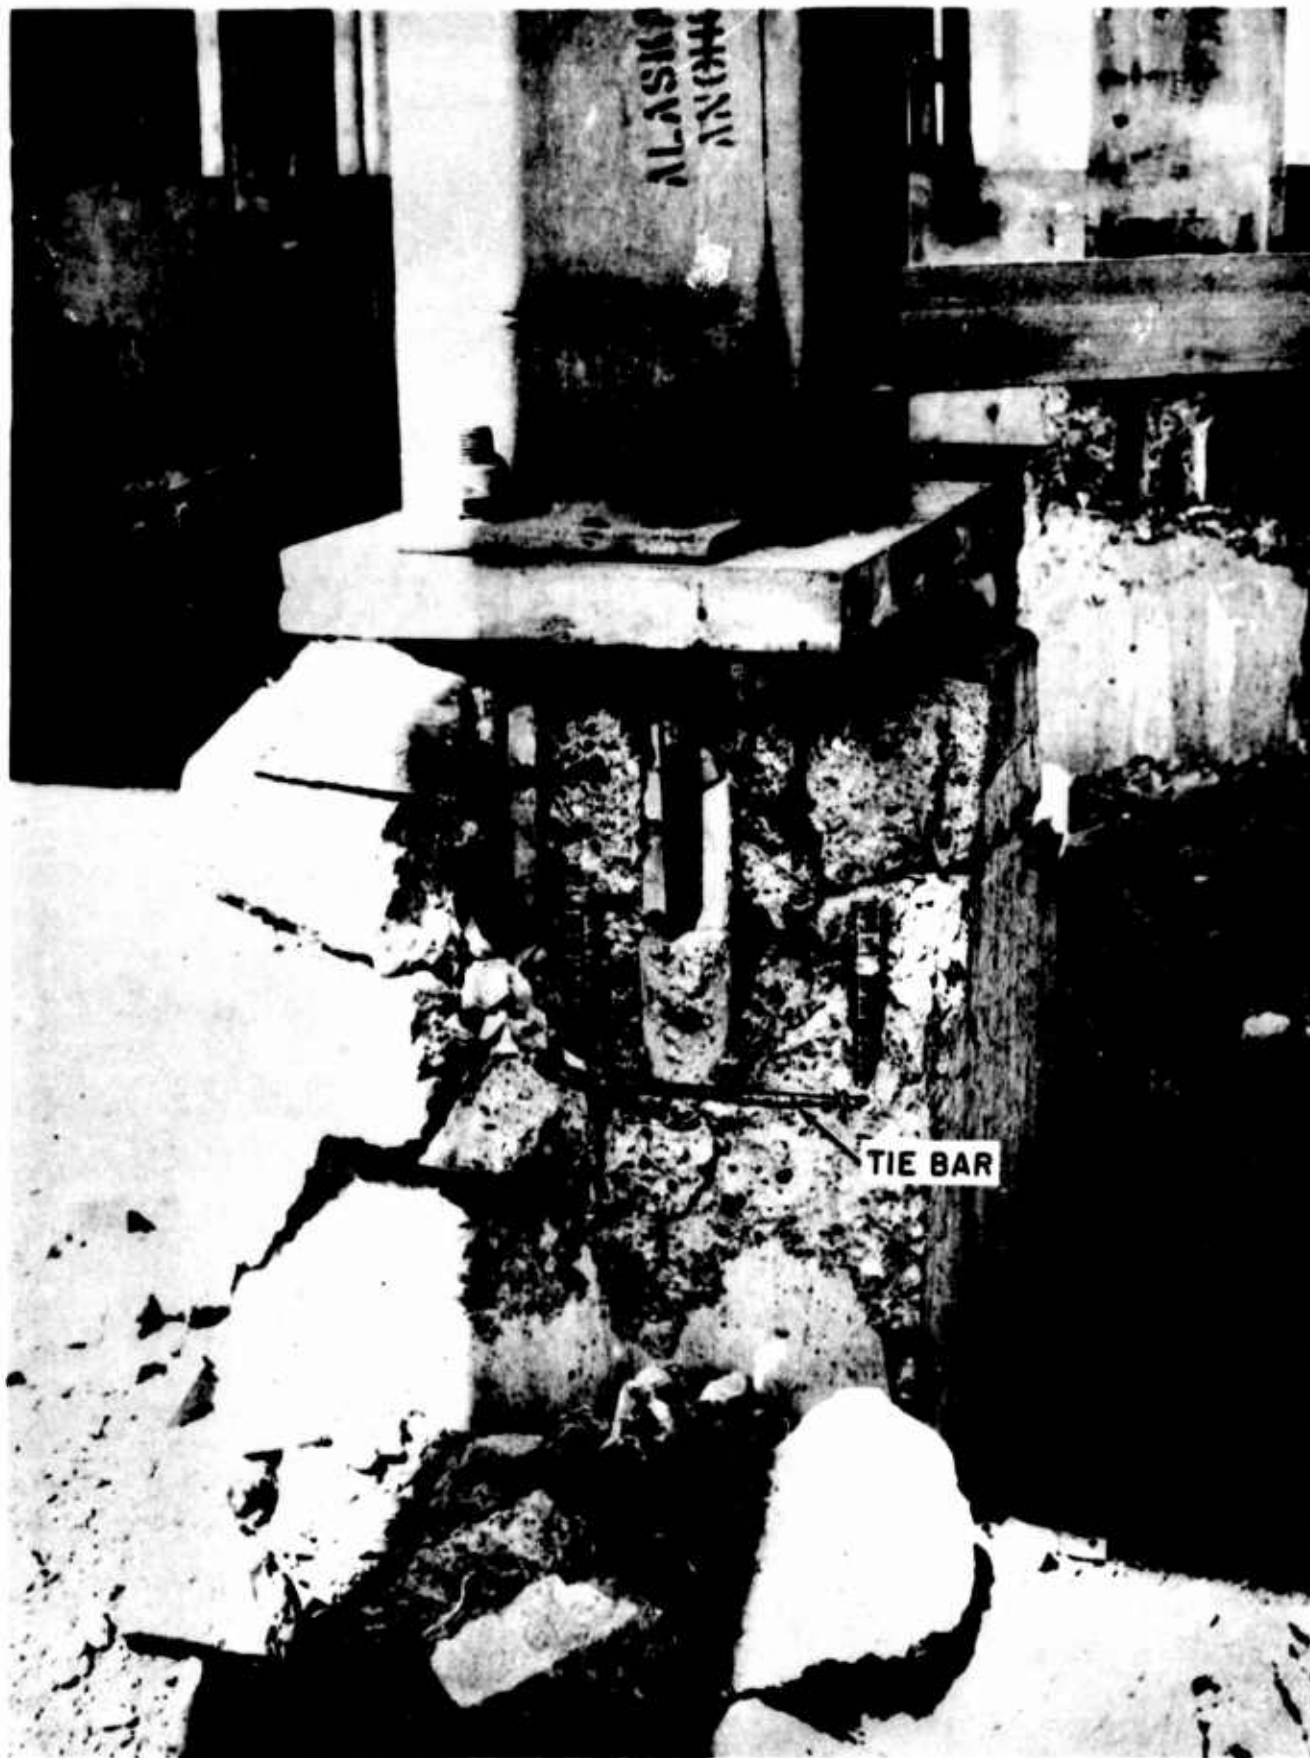
Figure 224. Alaska Brewery Company Structure
(Damage to an interior footing, mainly above first horizontal tie)

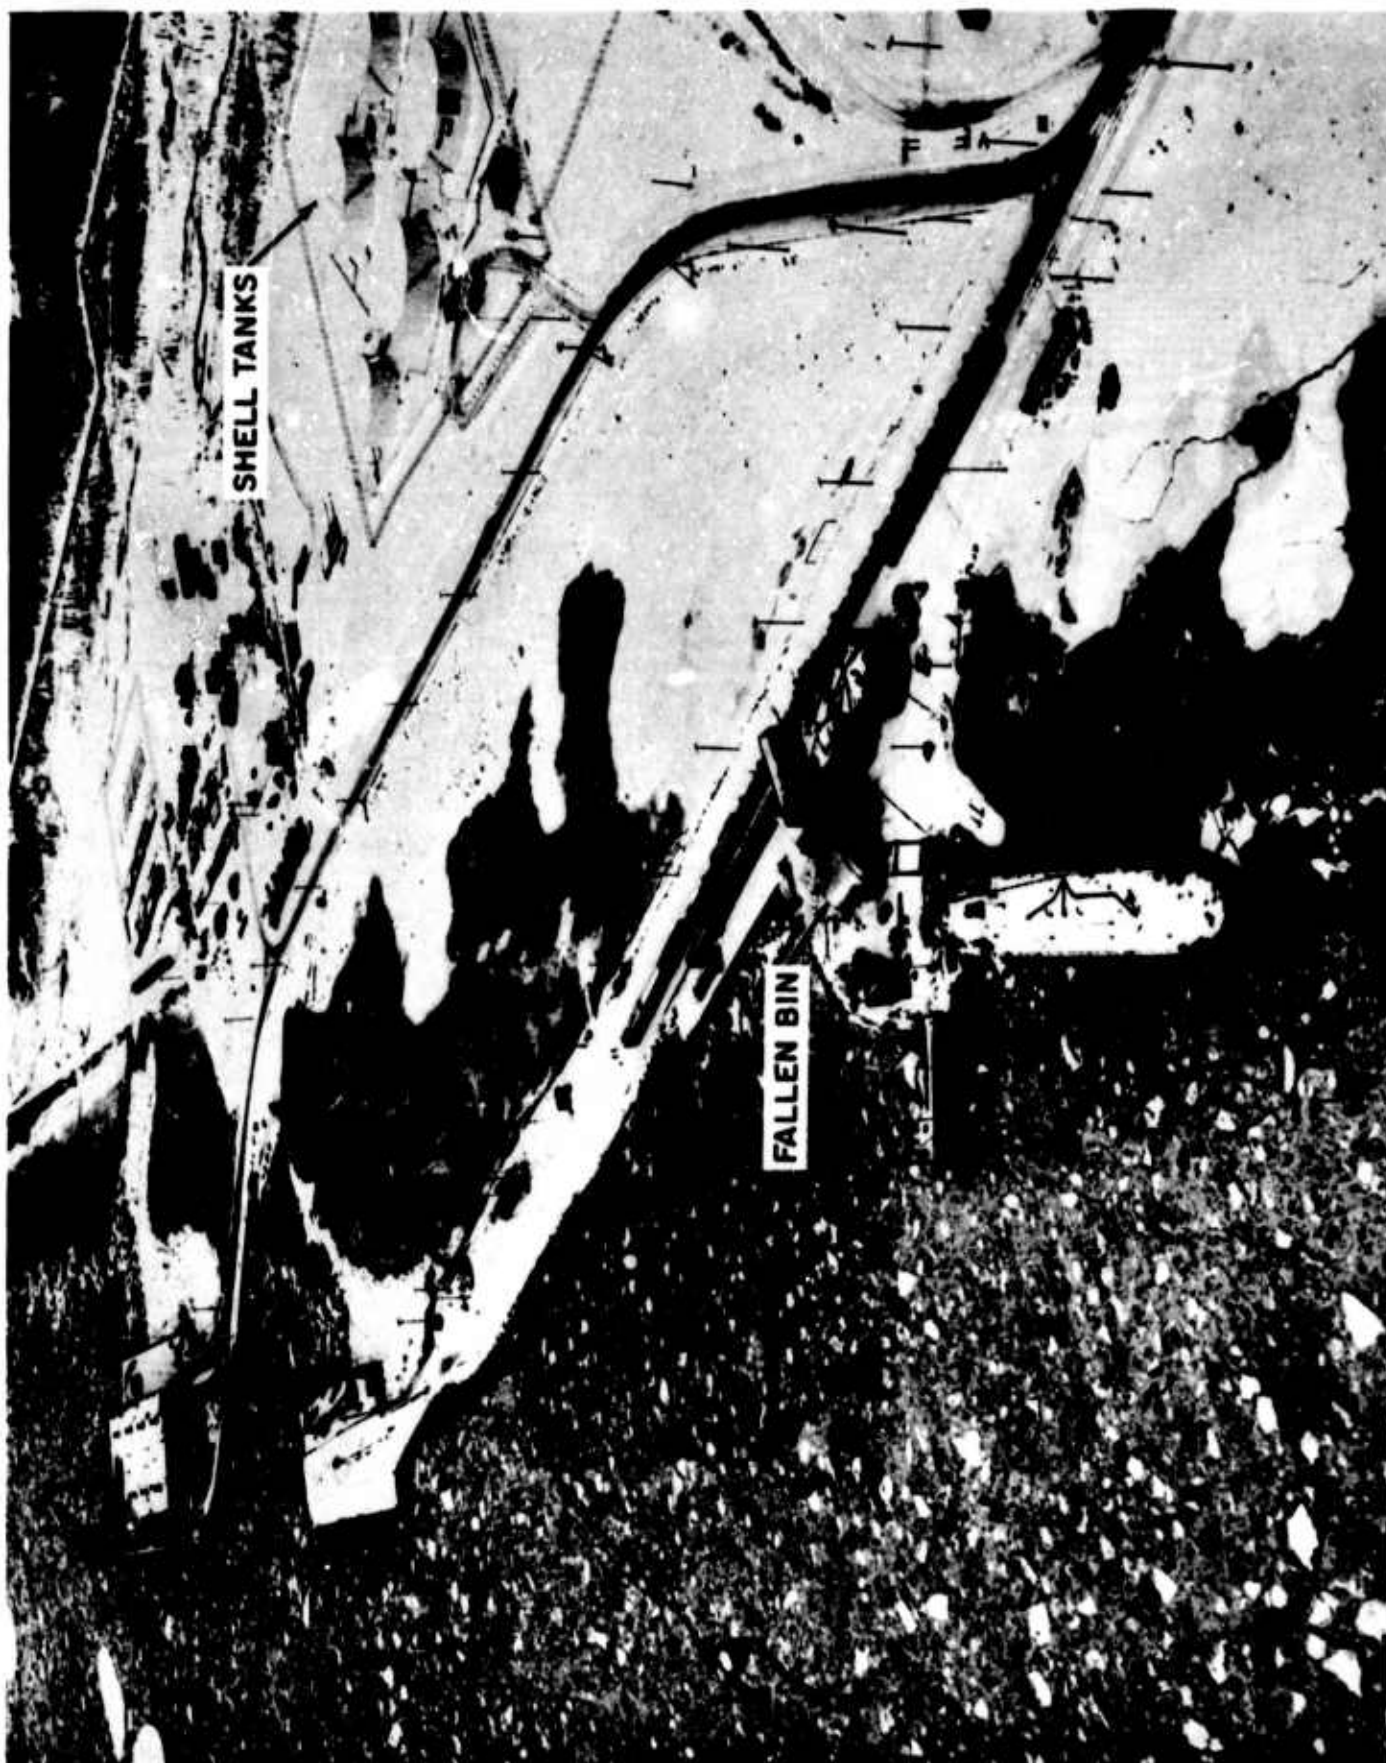
Figure 227. Permanente Cement Bin, Aerial View
(In upper right are the Shell Oil Company storage tanks discussed in section XII.6)

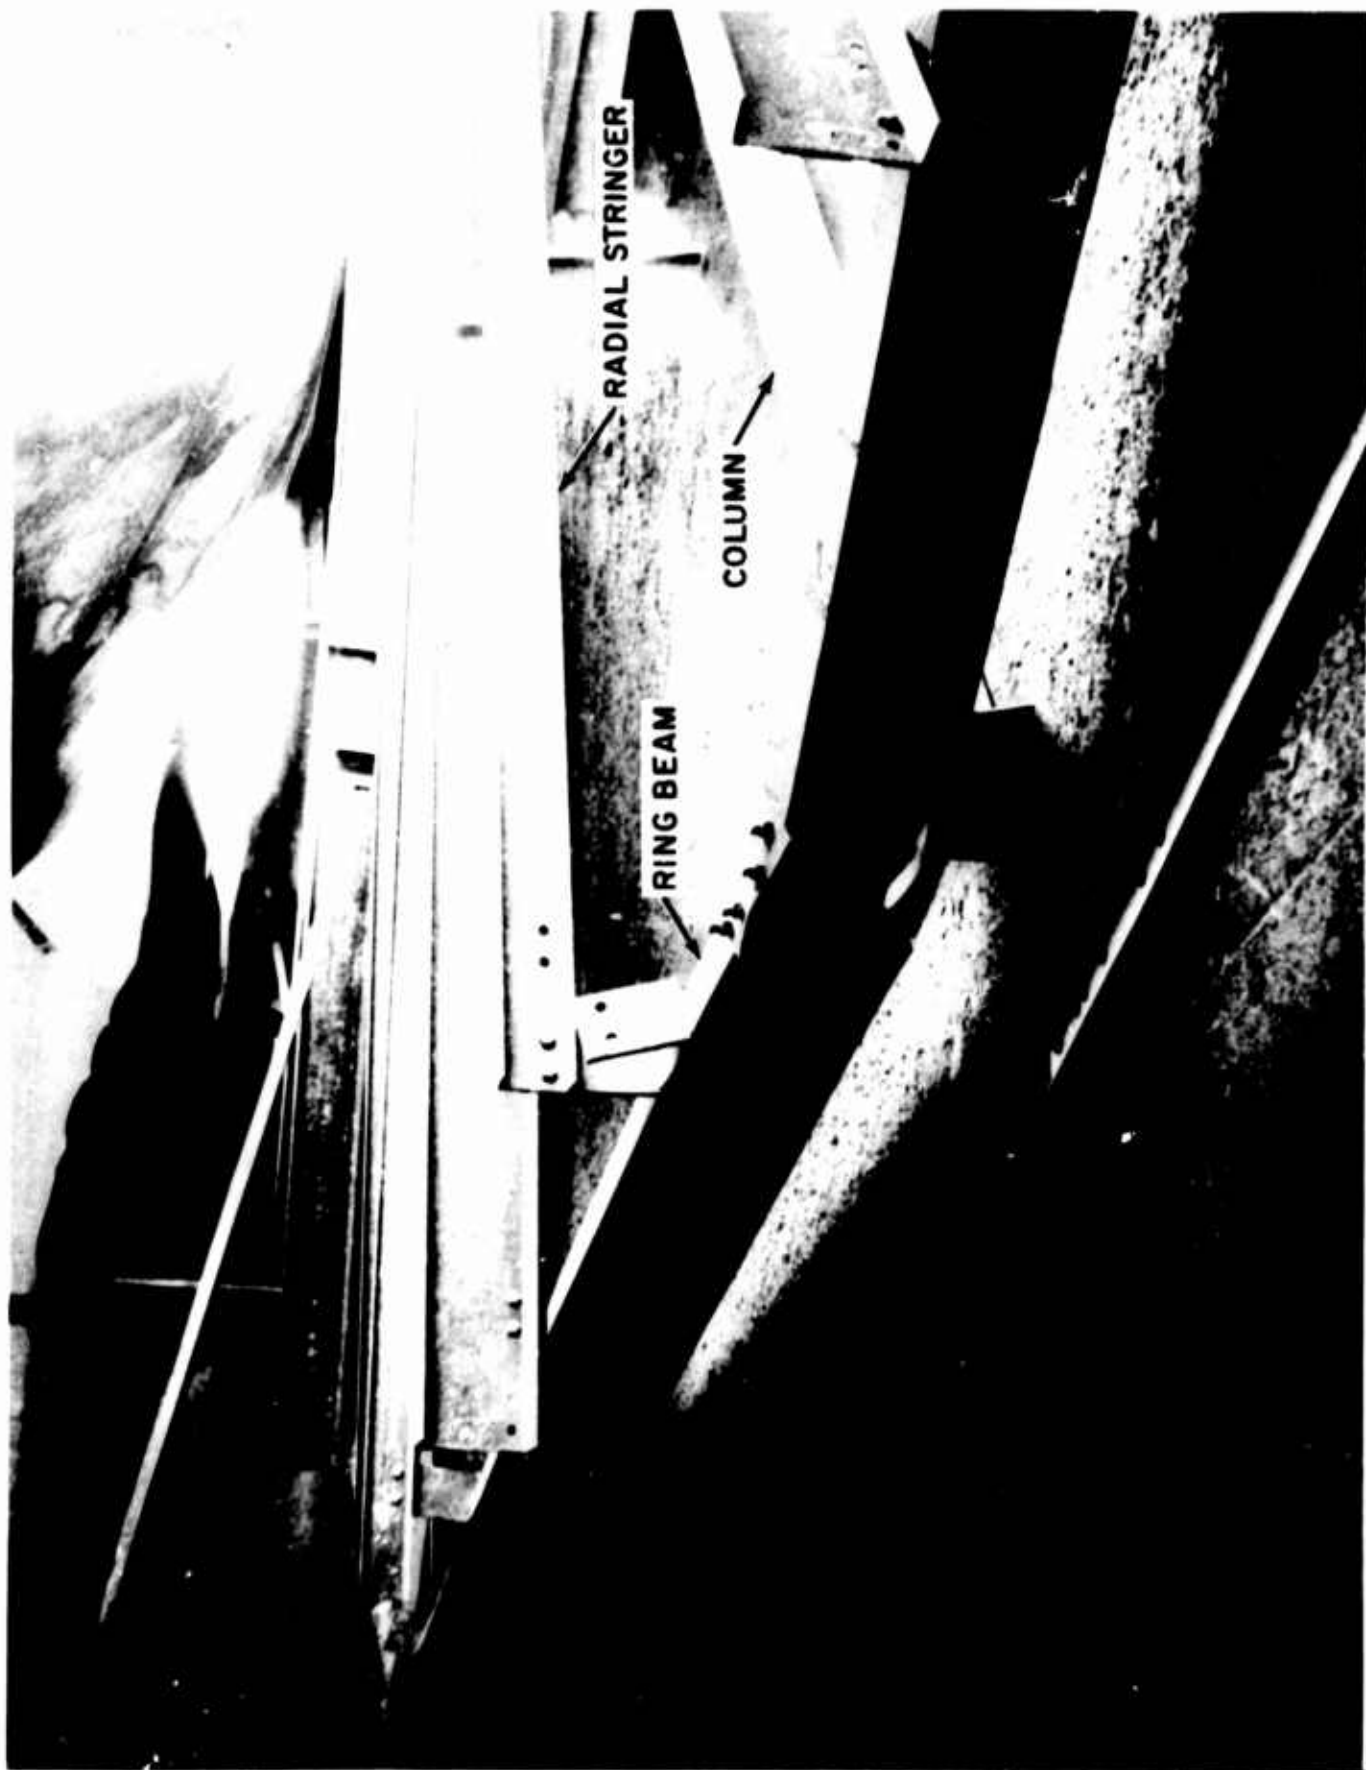
Figure 235. Shell Oil Company Waterfront Storage Tank (Fallen roof ring beam lying on floor of tank)

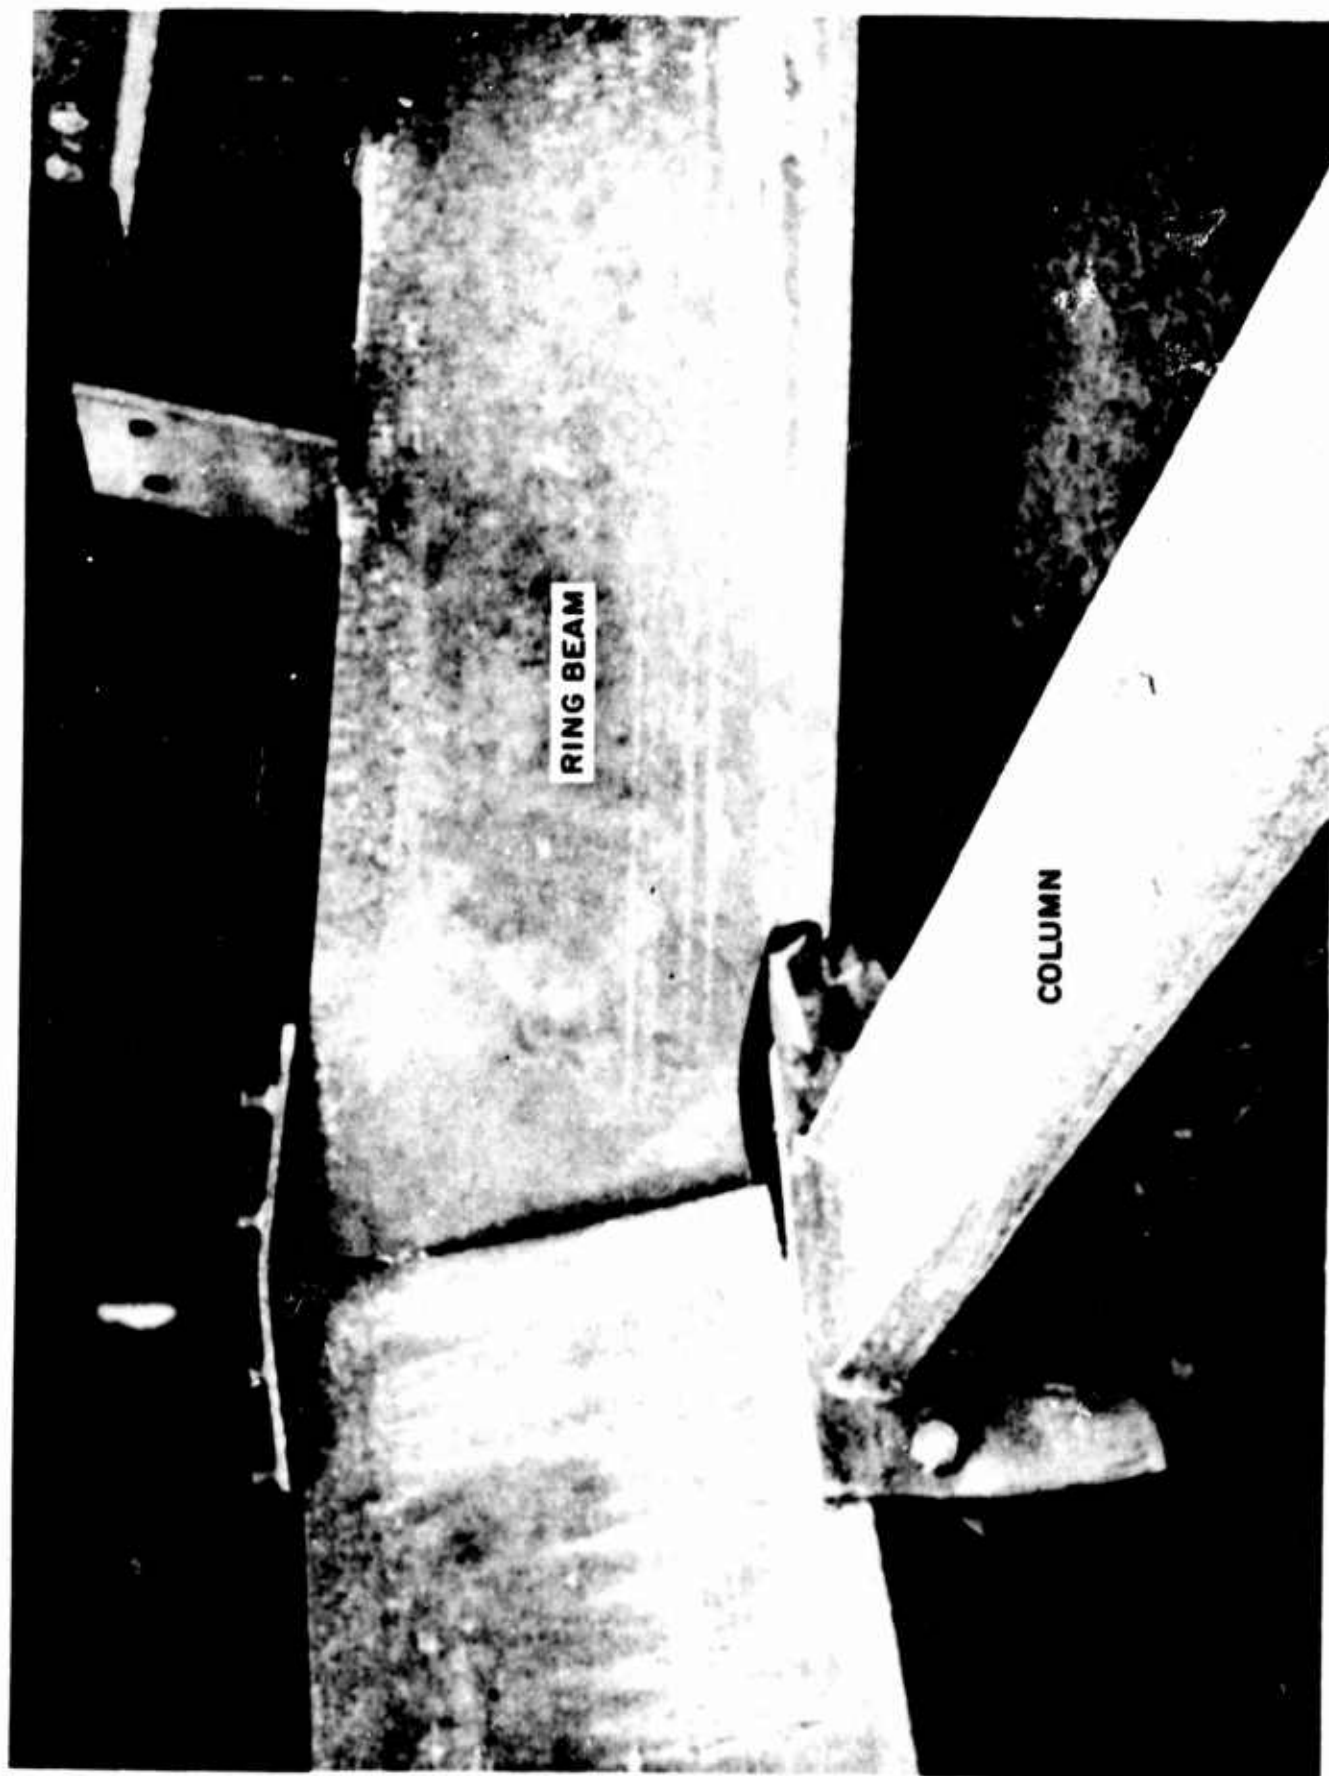
Figure 236. Shell Oil Company Waterfront Storage Tank
(Closeup of failed ring beam/column connection inside collapsed tank)

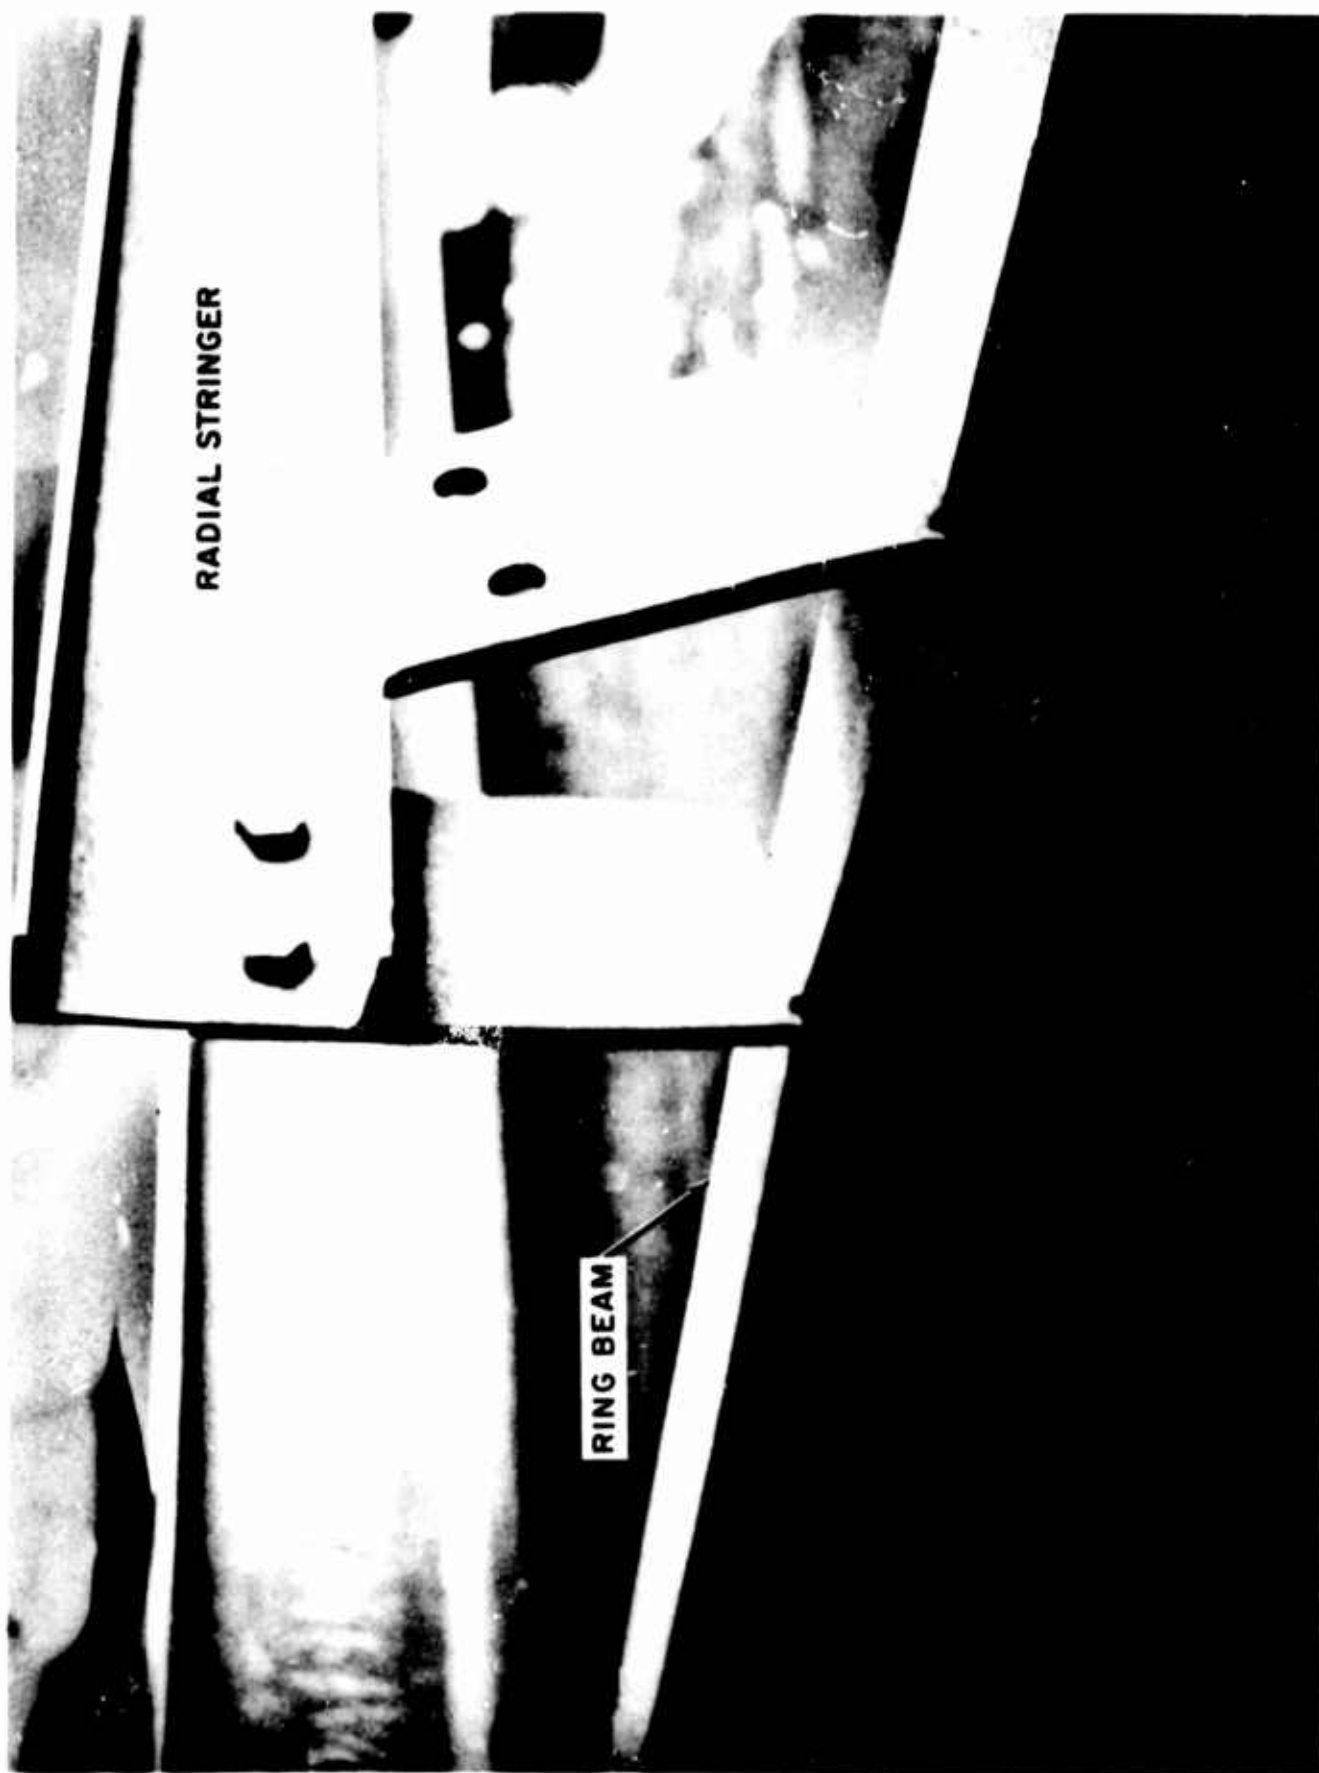
Figure 237. Shell Oil Company Waterfront Storage Tank
(Closeup of failed bolted connection between radial stringer and ring beam inside collapsed tank)
